Incident Report

Time/Site location 12775 Viscaino Road

**VISCAINO ROAD FIRE HYDRANT LATERAL REPLACEMENT
LOS ALTOS HILLS FIRE DISTRICT**

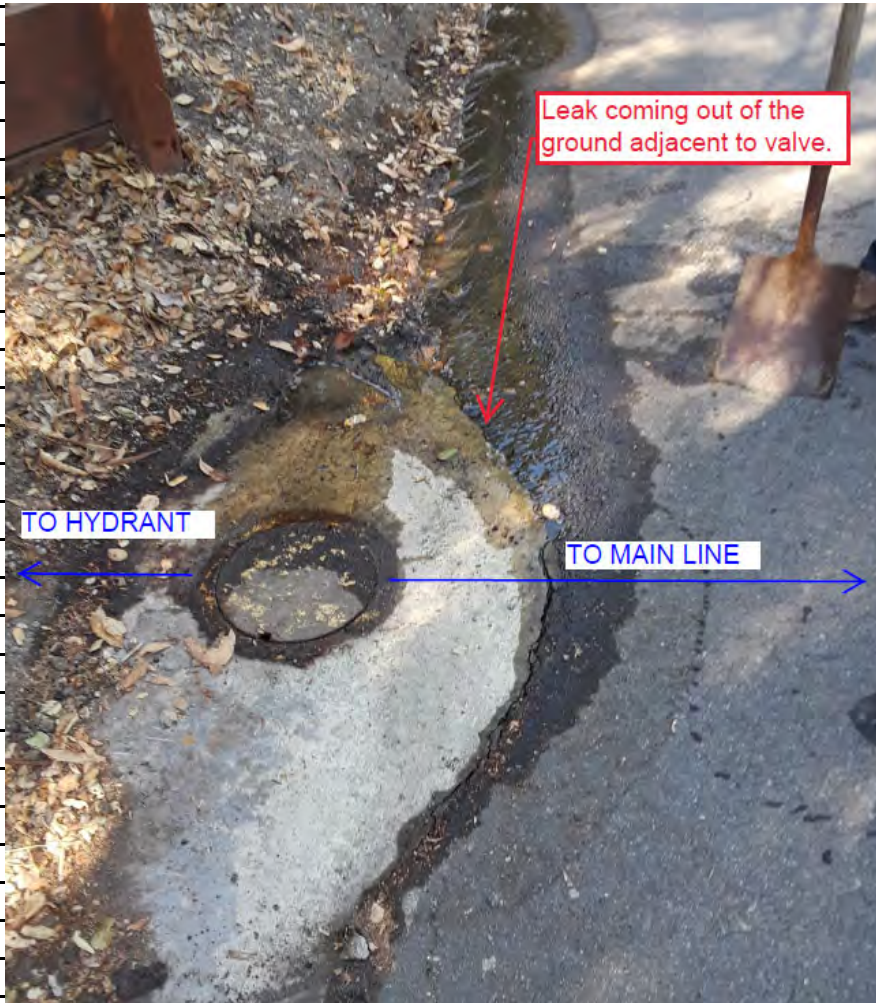
Water can be seen coming out of the ground adjacent to the fire hydrant shutoff valve.
 Because of the location of the valve and leak, a repair will require a shutdown of approximately 20 homes.
 The hydrant does not appear to have a Check Valve.
 Hydrant is in good condition and can be reused

Leak needs to be repaired.
 With its current configuration if the hydrant was damaged it would be very difficult to shut off.
 We recommend replacing the hydrant lateral, installing a check valve , and installing a new gate valve that would allow the hydrant/lateral to be isolated from the water main.
