**SUBJECT:** Mora-Summerhill Evacuation Route Project Final Reports

## **FINAL REPORT** **Mora - Summerhill Evacuation Route**

# POST TREATMENT REPORT

*SUMMERHILL AVENUE  
MAGDALENA AVENUE  
RAVENSBURY AVENUE  
MORA DRIVE*

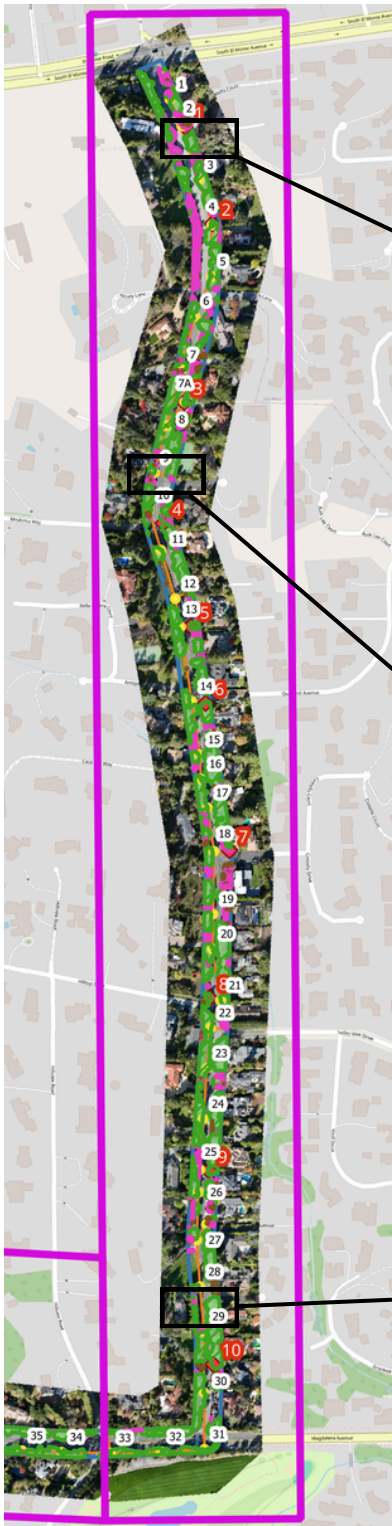
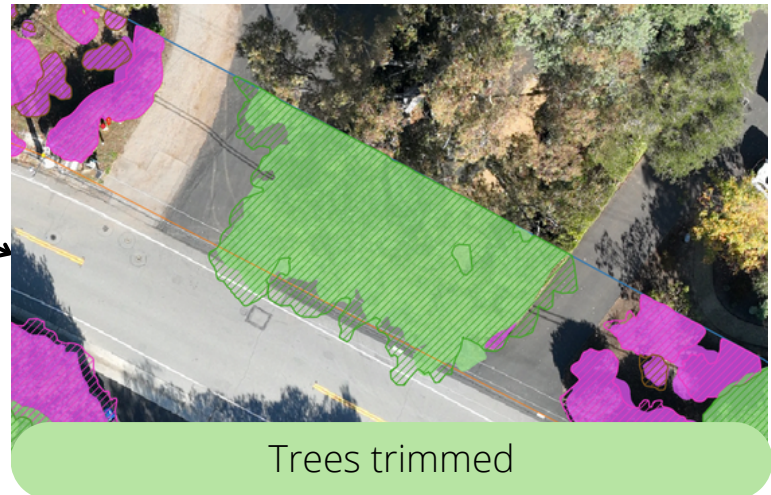
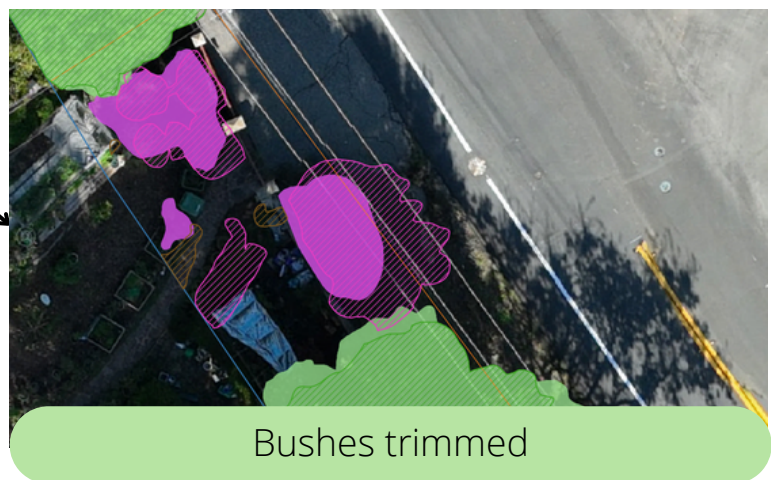
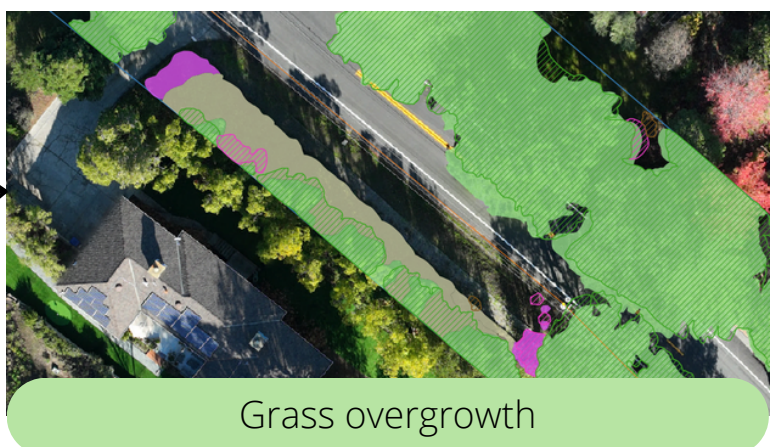
## 1st mile

# CHANGES: BEFORE (JUL) - AFTER (NOV) (1ST MILE)

Low vegetation before		Low vegetation after
	Medium vegetation before		Medium vegetation after
	High vegetation before		High vegetation after

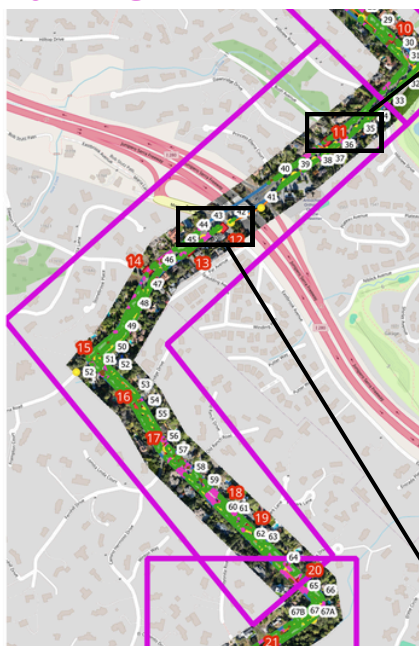
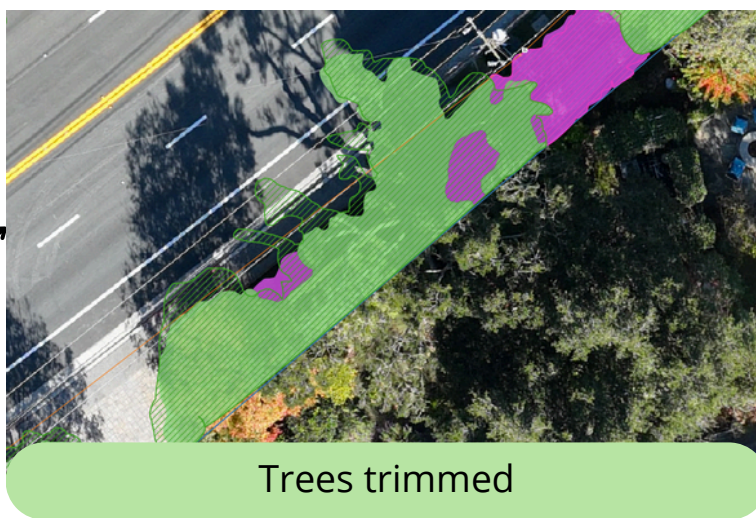
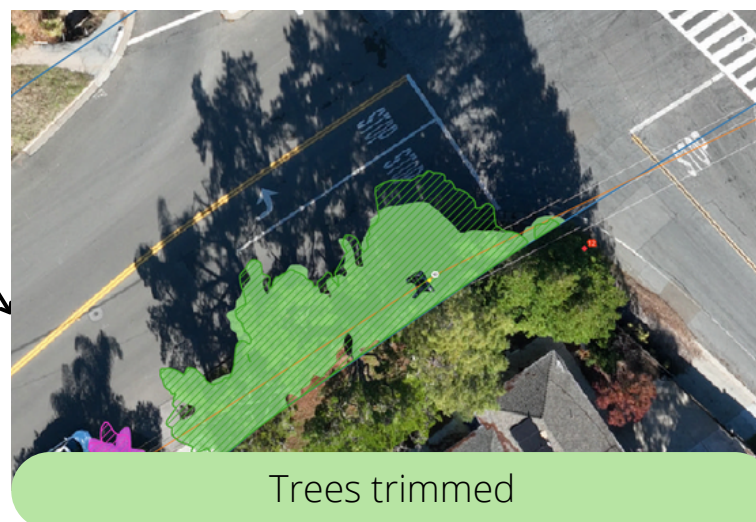
2nd mile

## CHANGES: BEFORE (JUL) - AFTER (NOV) (2ND MILE)

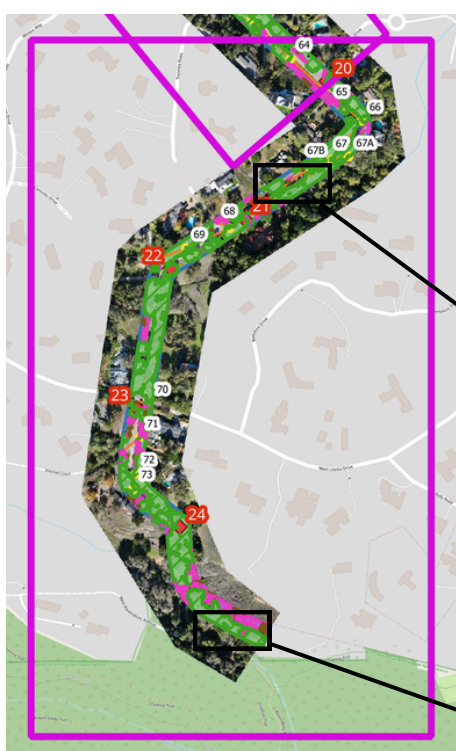
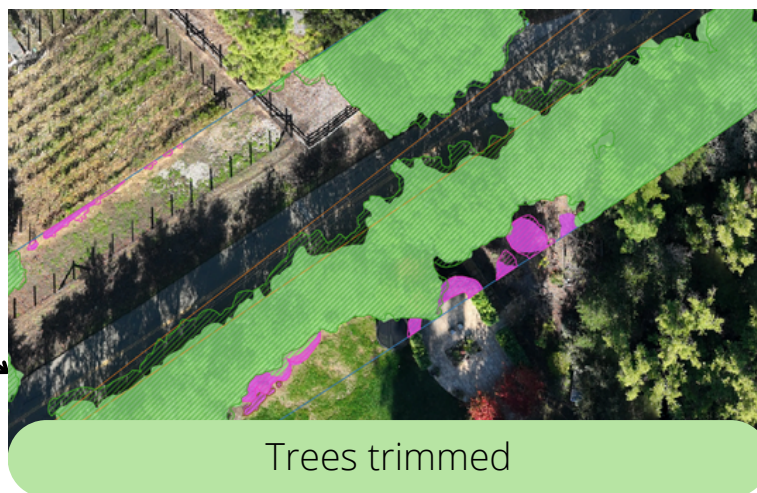
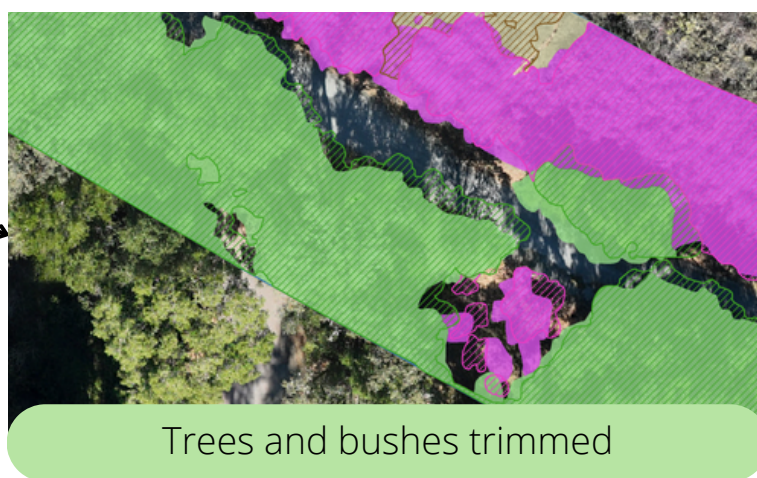
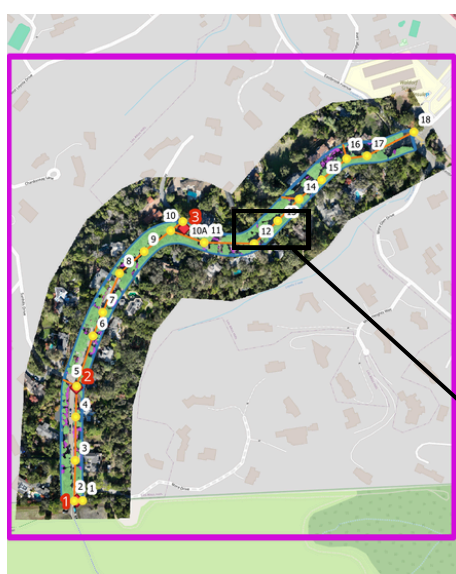
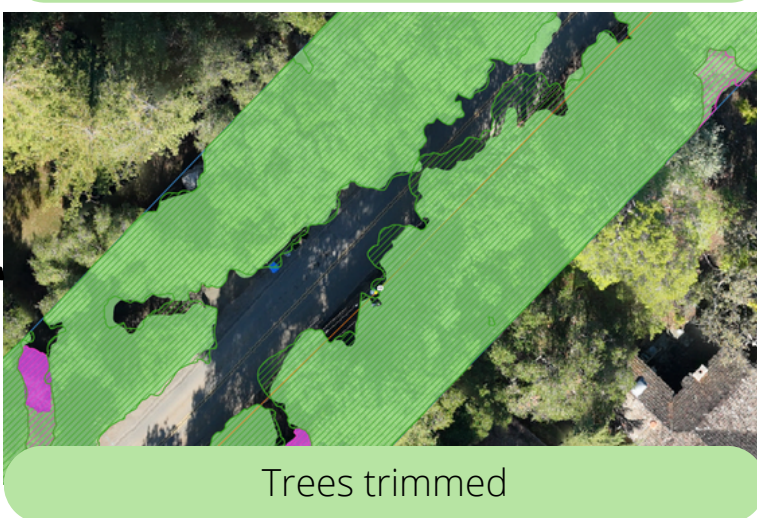
## 3rd mile

# CHANGES: BEFORE (JUL) - AFTER (NOV) (3RD MILE)

High vegetation after

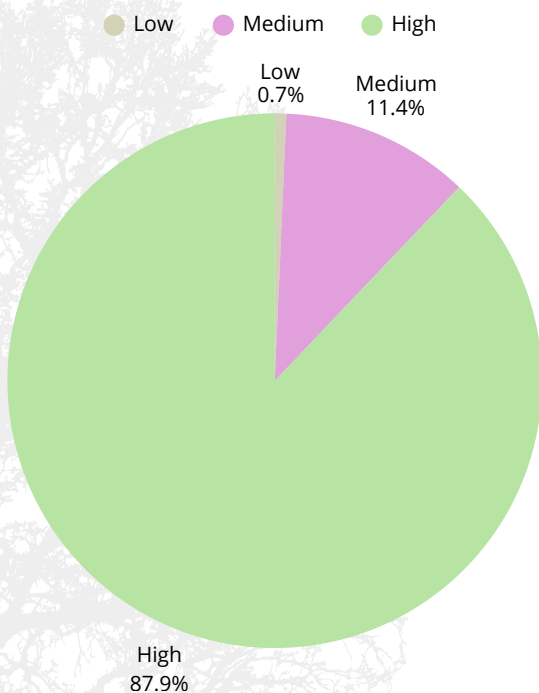
Vegetation area, %

A primary goal of an evacuation route treatment is to reduce low height vegetation such as grasses and medium height vegetation such as shrubs and saplings that are ladder fuels. Finally the retention of a healthy tree canopy in the high height provides shade and cooler temperatures.

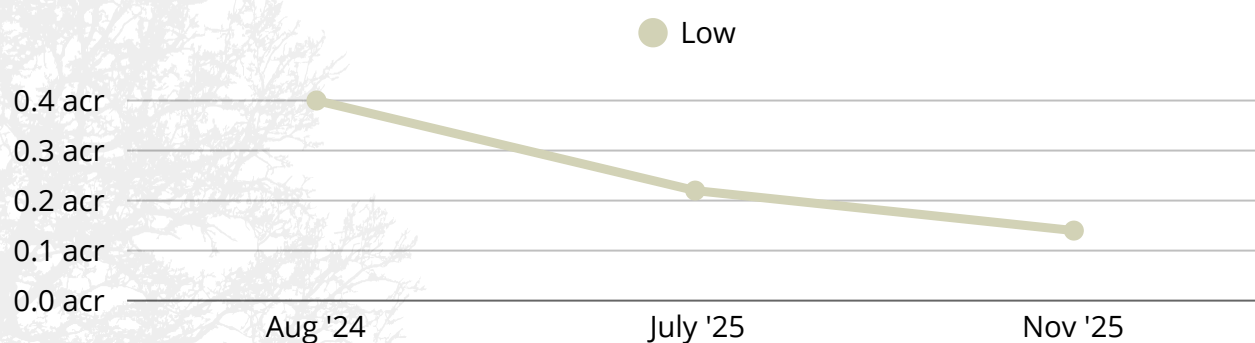
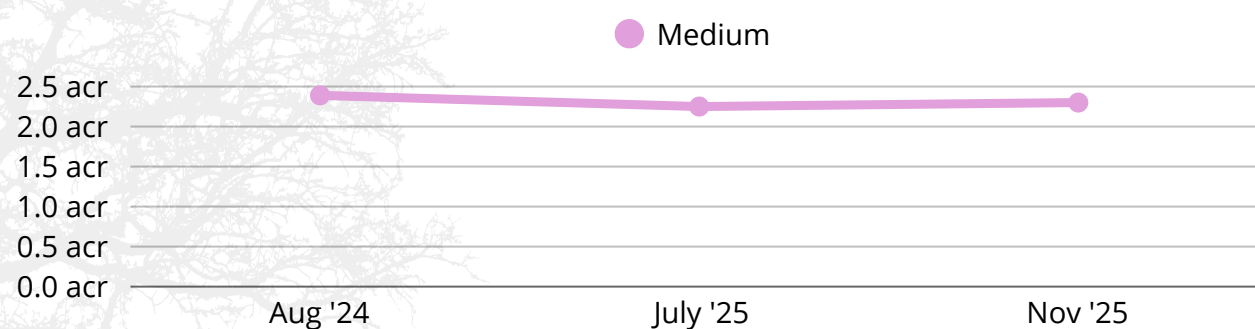
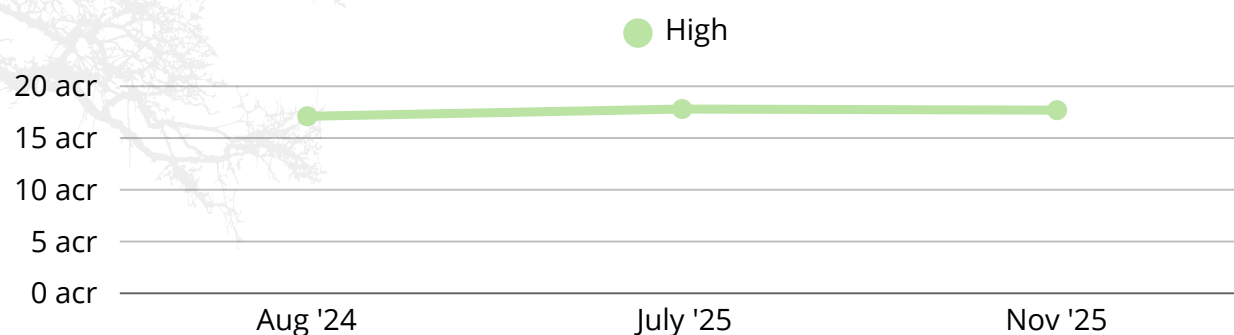
Vegetation height/ Areas (acres)	Aug '24	July '25	Nov' 2025	Acreage change
Low (up to 1 m)	0.4	0.22	0.14	-36%
Medium (1-5 m)	2.39	2.25	2.3	+2%
High (more than 5 m)	17.1	17.8	17.69	-0.6%

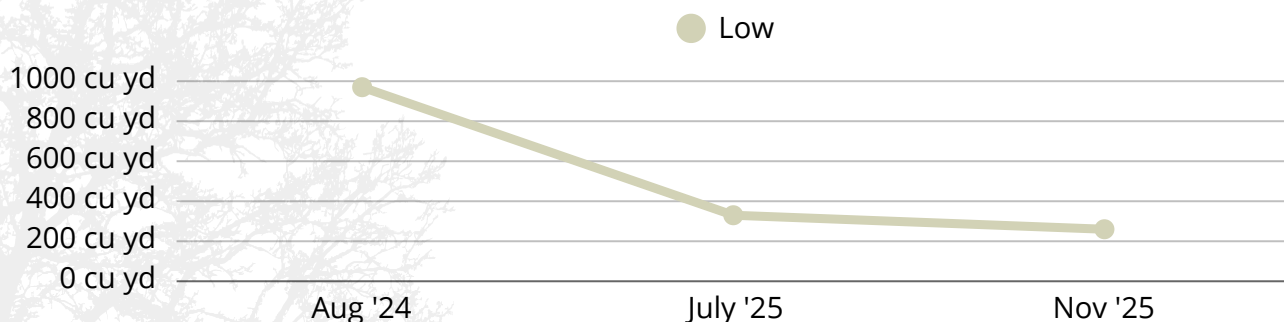
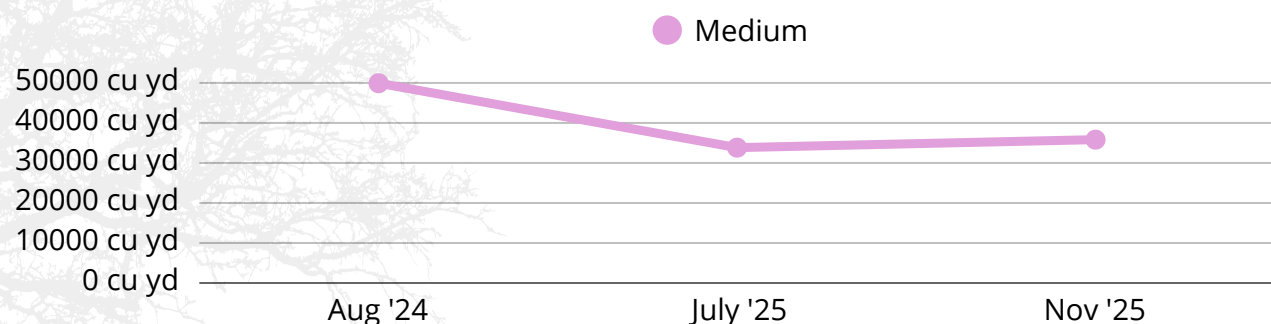
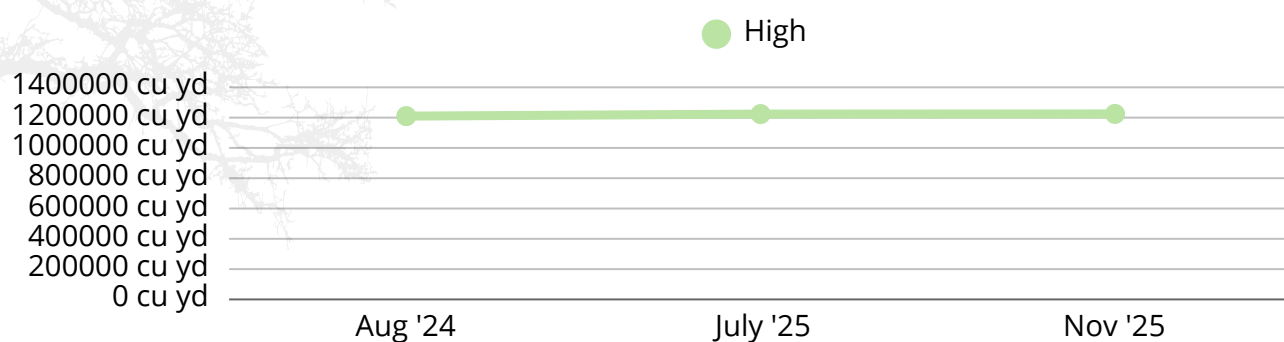
Volume is another way to measure a primary goal of an evacuation route treatment. Again the goal is to reduce low height vegetation and medium height vegetation. Retention of high height vegetation creates a shaded fuel break effect.

Vegetation height/ Volume (cubic yards)	Aug '24	July '25	Nov '25	Volume change
Low (up to 1 m)	970	330	260	-21%
Medium (1-5 m)	49,929	33,828	35,827	+6%
High (more than 5 m)	1,209,953	1,223,392	1,224,404	≈0%

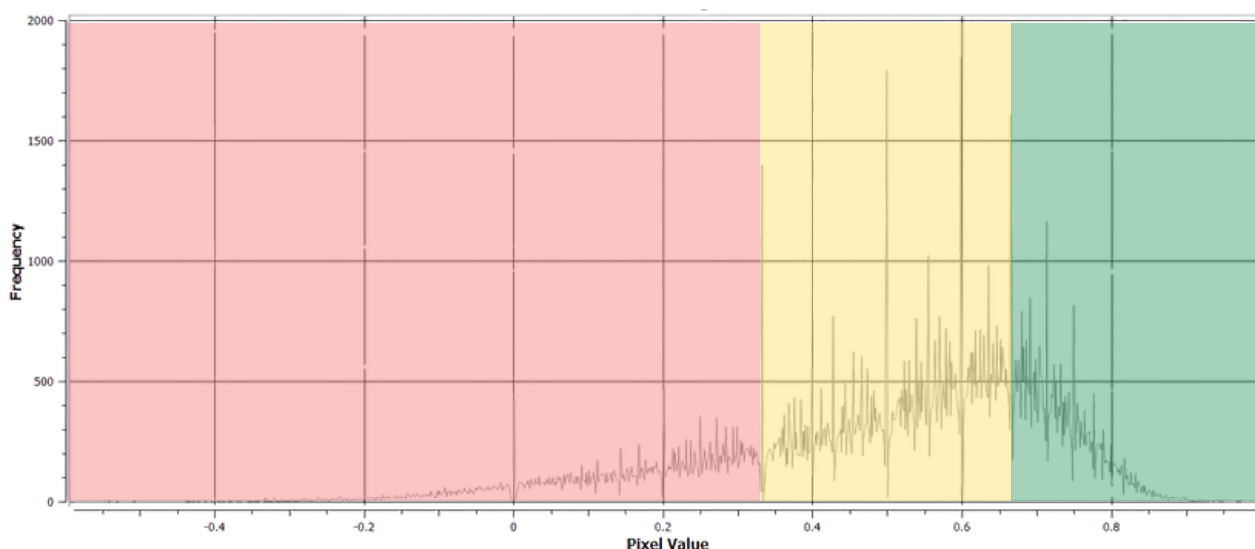
NDVI Distribution Chart

**NDVI, or Normalized Difference Vegetation Index,** is a numerical indicator used to assess the presence and health of vegetation by analyzing how surfaces reflect light at specific wavelengths. It is calculated using the formula  $(NIR - Red) / (NIR + Red)$ , where NIR stands for near-infrared reflectance and Red refers to red light reflectance.

The NDVI values range between -1 and +1. Values closer to +1 indicate dense, healthy vegetation, such as a forest canopy or thriving crop field. Moderate values (around 0.3 to 0.66) suggest sparser or less healthy vegetation like grasslands or shrubs. Values near zero or negative values typically represent diseased or dead plants.

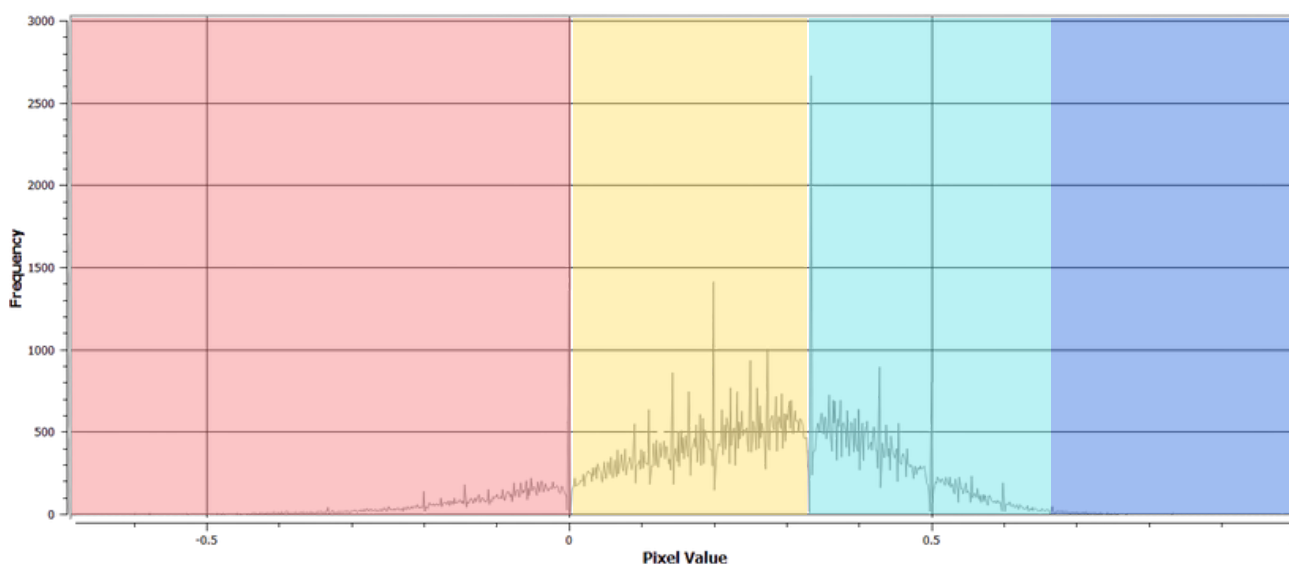
### GNDVI Distribution Chart

**GNDVI, or Green Normalized Difference Vegetation Index,** is a vegetation index similar to NDVI but it uses the green band instead of the red band. It is particularly sensitive to chlorophyll content in leaves and is often used for assessing plant water stress, nitrogen content, or overall plant vigor, especially in crops with high chlorophyll concentrations.

The output values range from -1 to +1, just like NDVI. Higher values indicate high level of moisture in plants, while lower or negative values suggest sparse and water stressed vegetation. Compared to NDVI, GNDVI may be more sensitive to early signs of water or nitrogen deficiency, since green reflectance changes earlier in response to plant stress.
