Management of District-Owned Hydrant & Hydrant Related Infrastructure

Los Altos Hills County Fire District
March 16, 2021 Commission Meeting

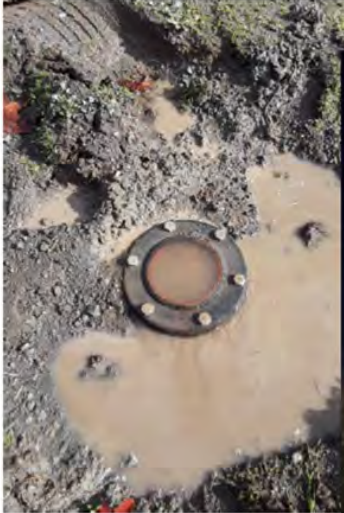
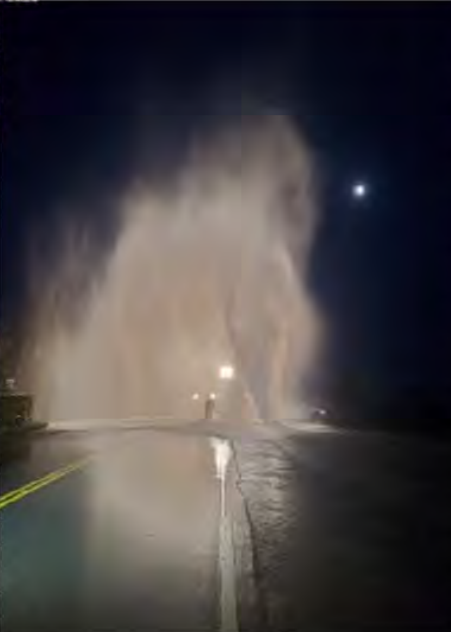
Date	1/5/2021						
Day	S	M	T	W	THz	F	Sat
			X				
Weather	43F Clear				Time	12:30pm	
Time/Site location Intersection of Altamont Rd & Black Mountain Rd							
Comments							
Fire Hydrant hit by Car.							
Clean break at the breakaway spool							
The Check Valve is not functioning properly							
Required Work							
Hydrant was not on site, but from our understanding it's in good condition and can be reused							
Breakaway spool will need to be replaced							
Check valve needs to be replaced

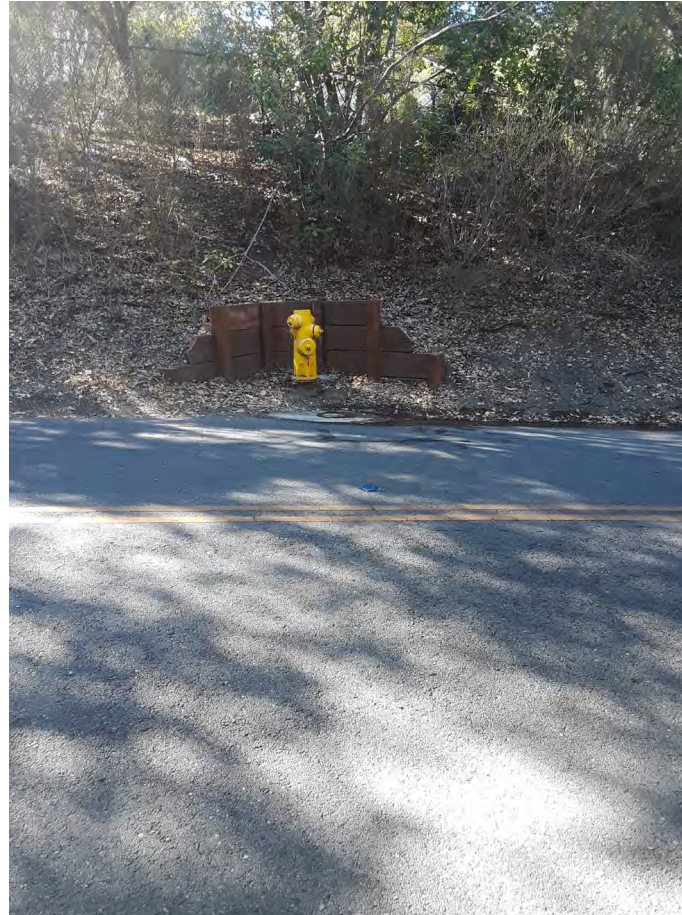
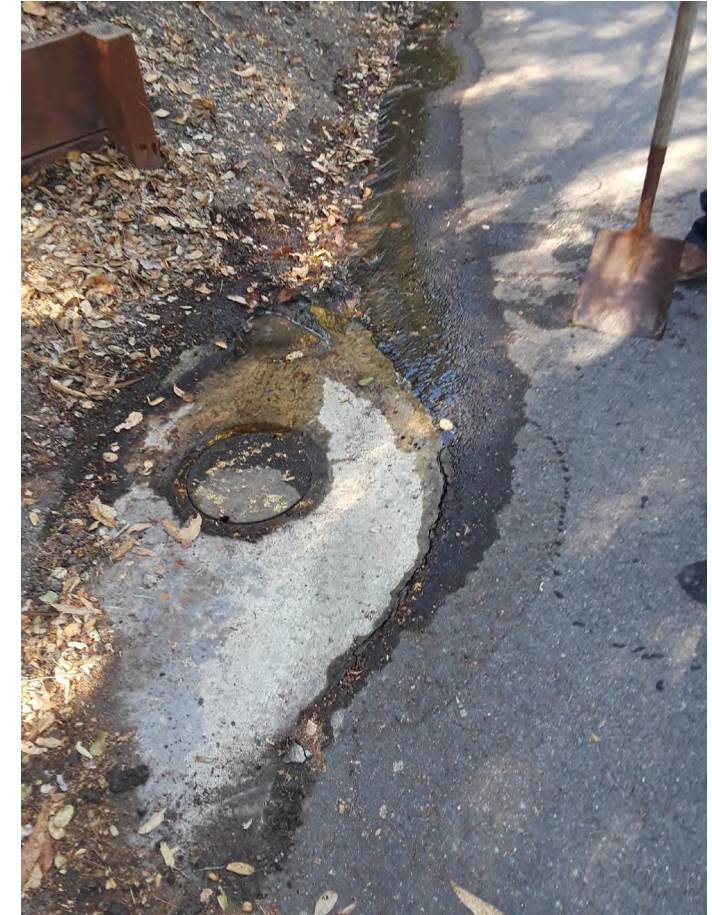
- Notified by PHWD that a leak observed at fire hydrant near 12775 Viscaino Road
- Visual observation indicated leak at valve adjacent to hydrant

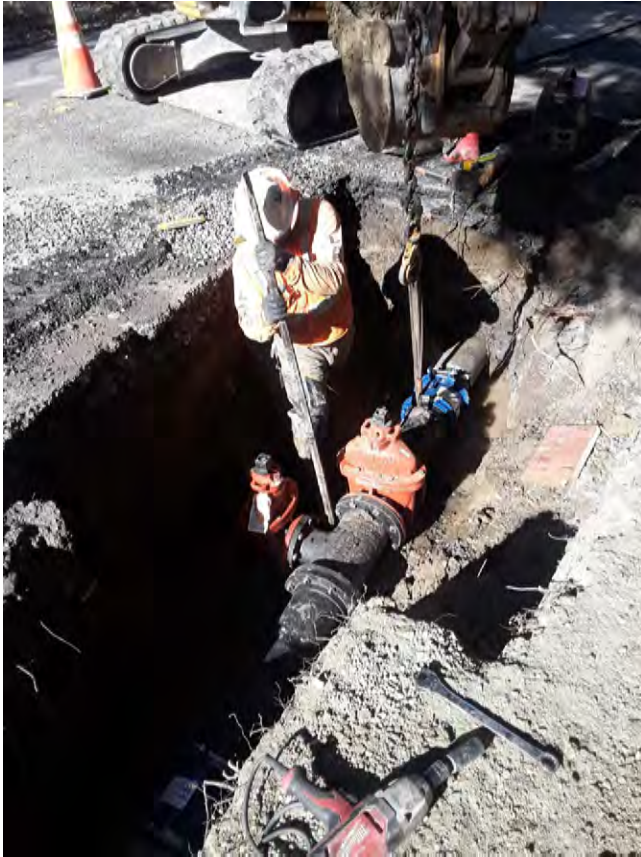
New Tee and Valve on
District side of PHWD
Main

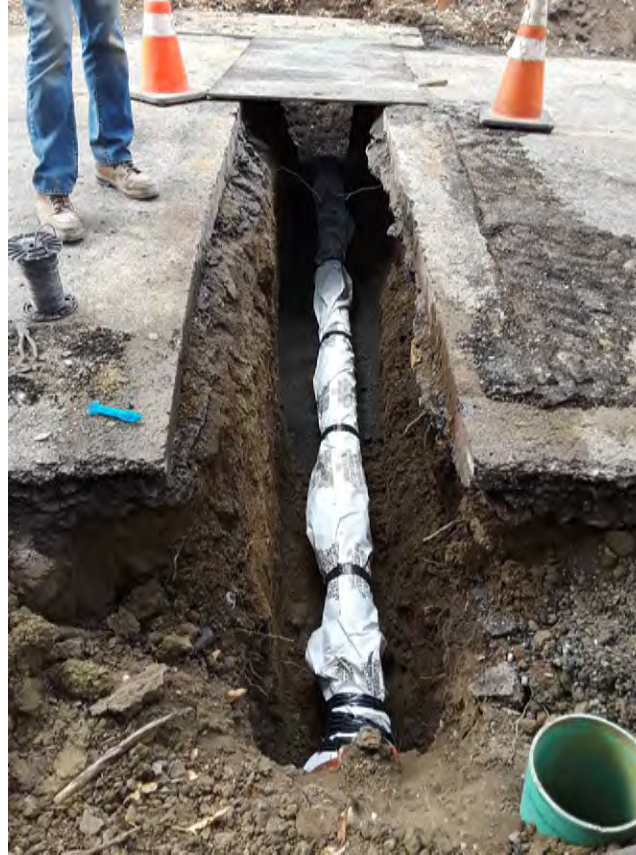
New Lateral Connecting
to Valve at Tee

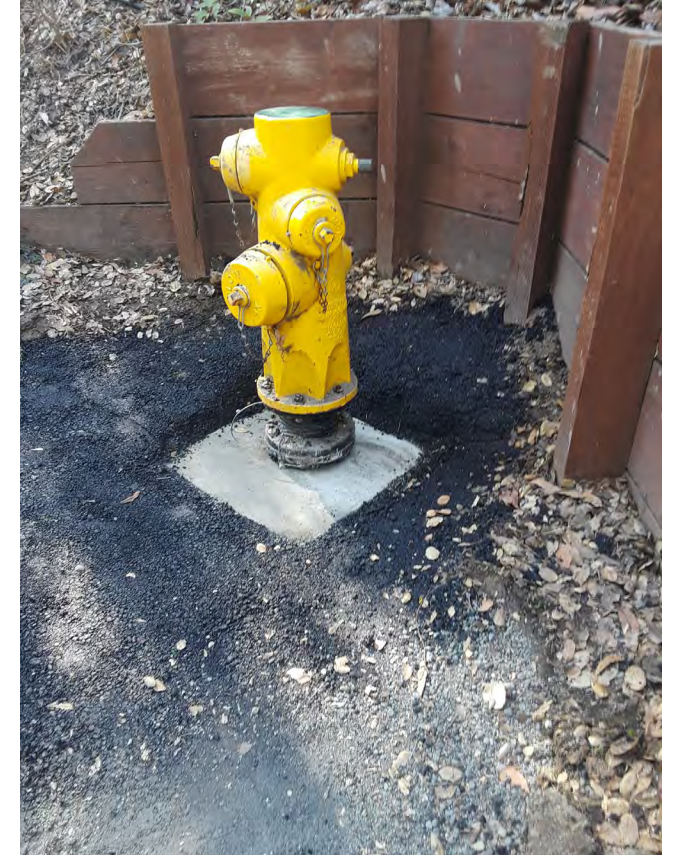
Reinstalled Fire Hydrant

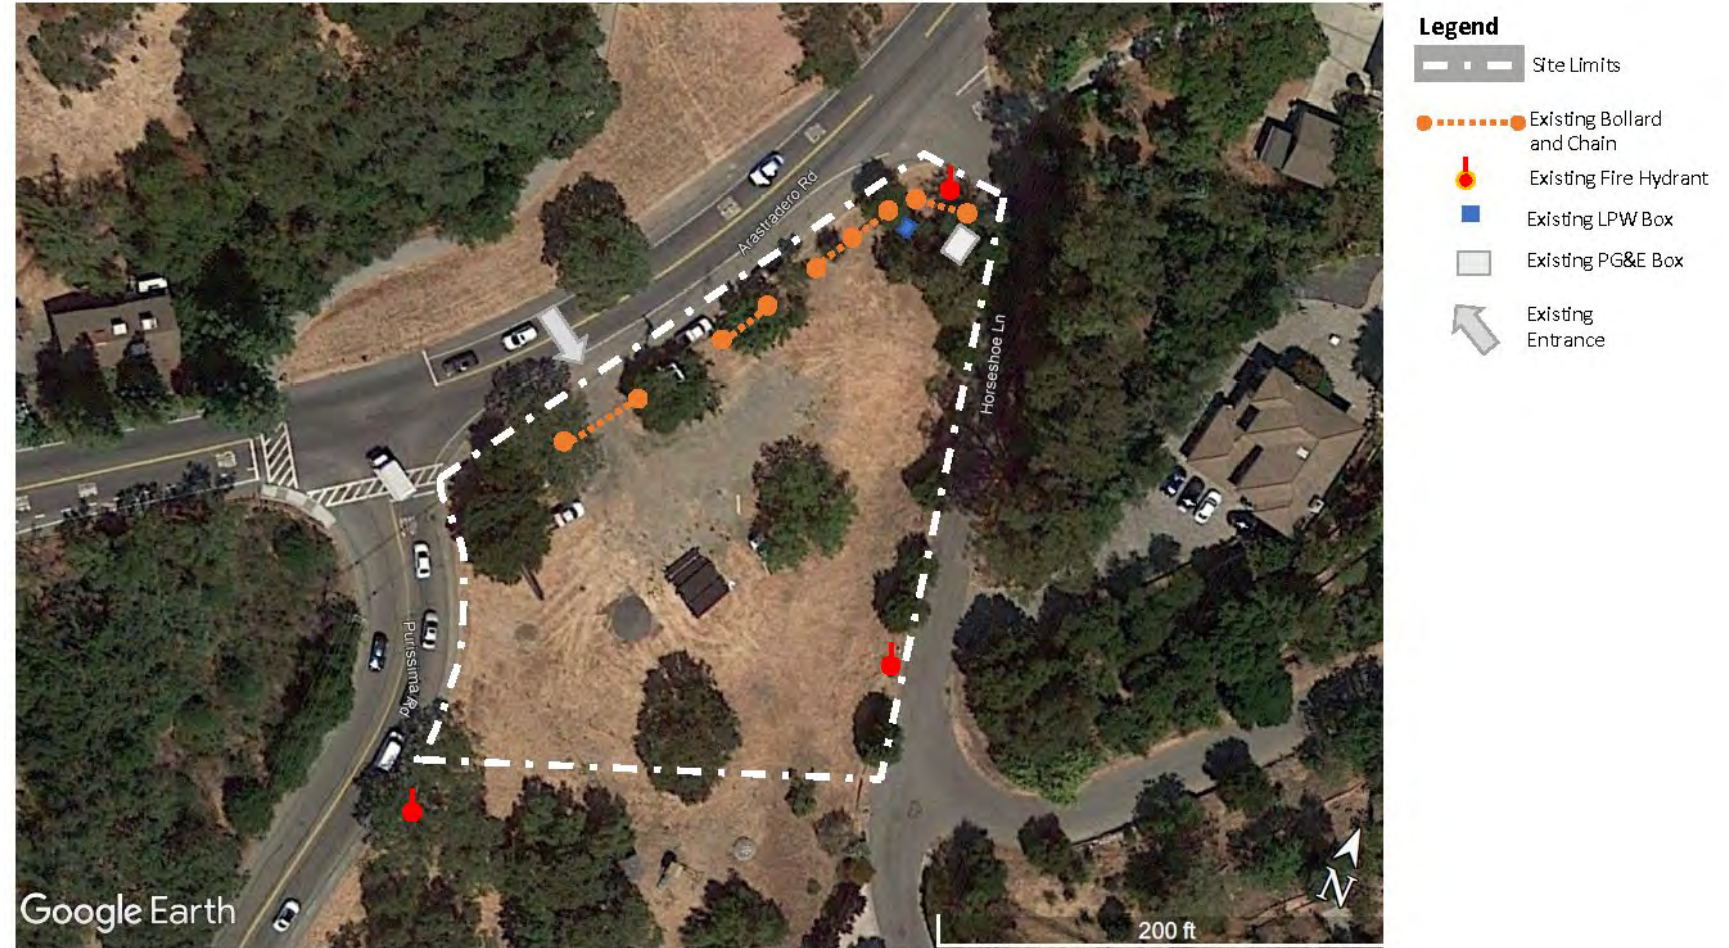
Figure 1. Existing Conditions

- District-owned Parcel
- Develop conceptual layout for staging during emergencies
- Enhance site protections
