Incident Report

Time/Site location 12775 Viscaino Road

**VISCAINO ROAD FIRE HYDRANT LATERAL REPLACEMENT
LOS ALTOS HILLS FIRE DISTRICT**

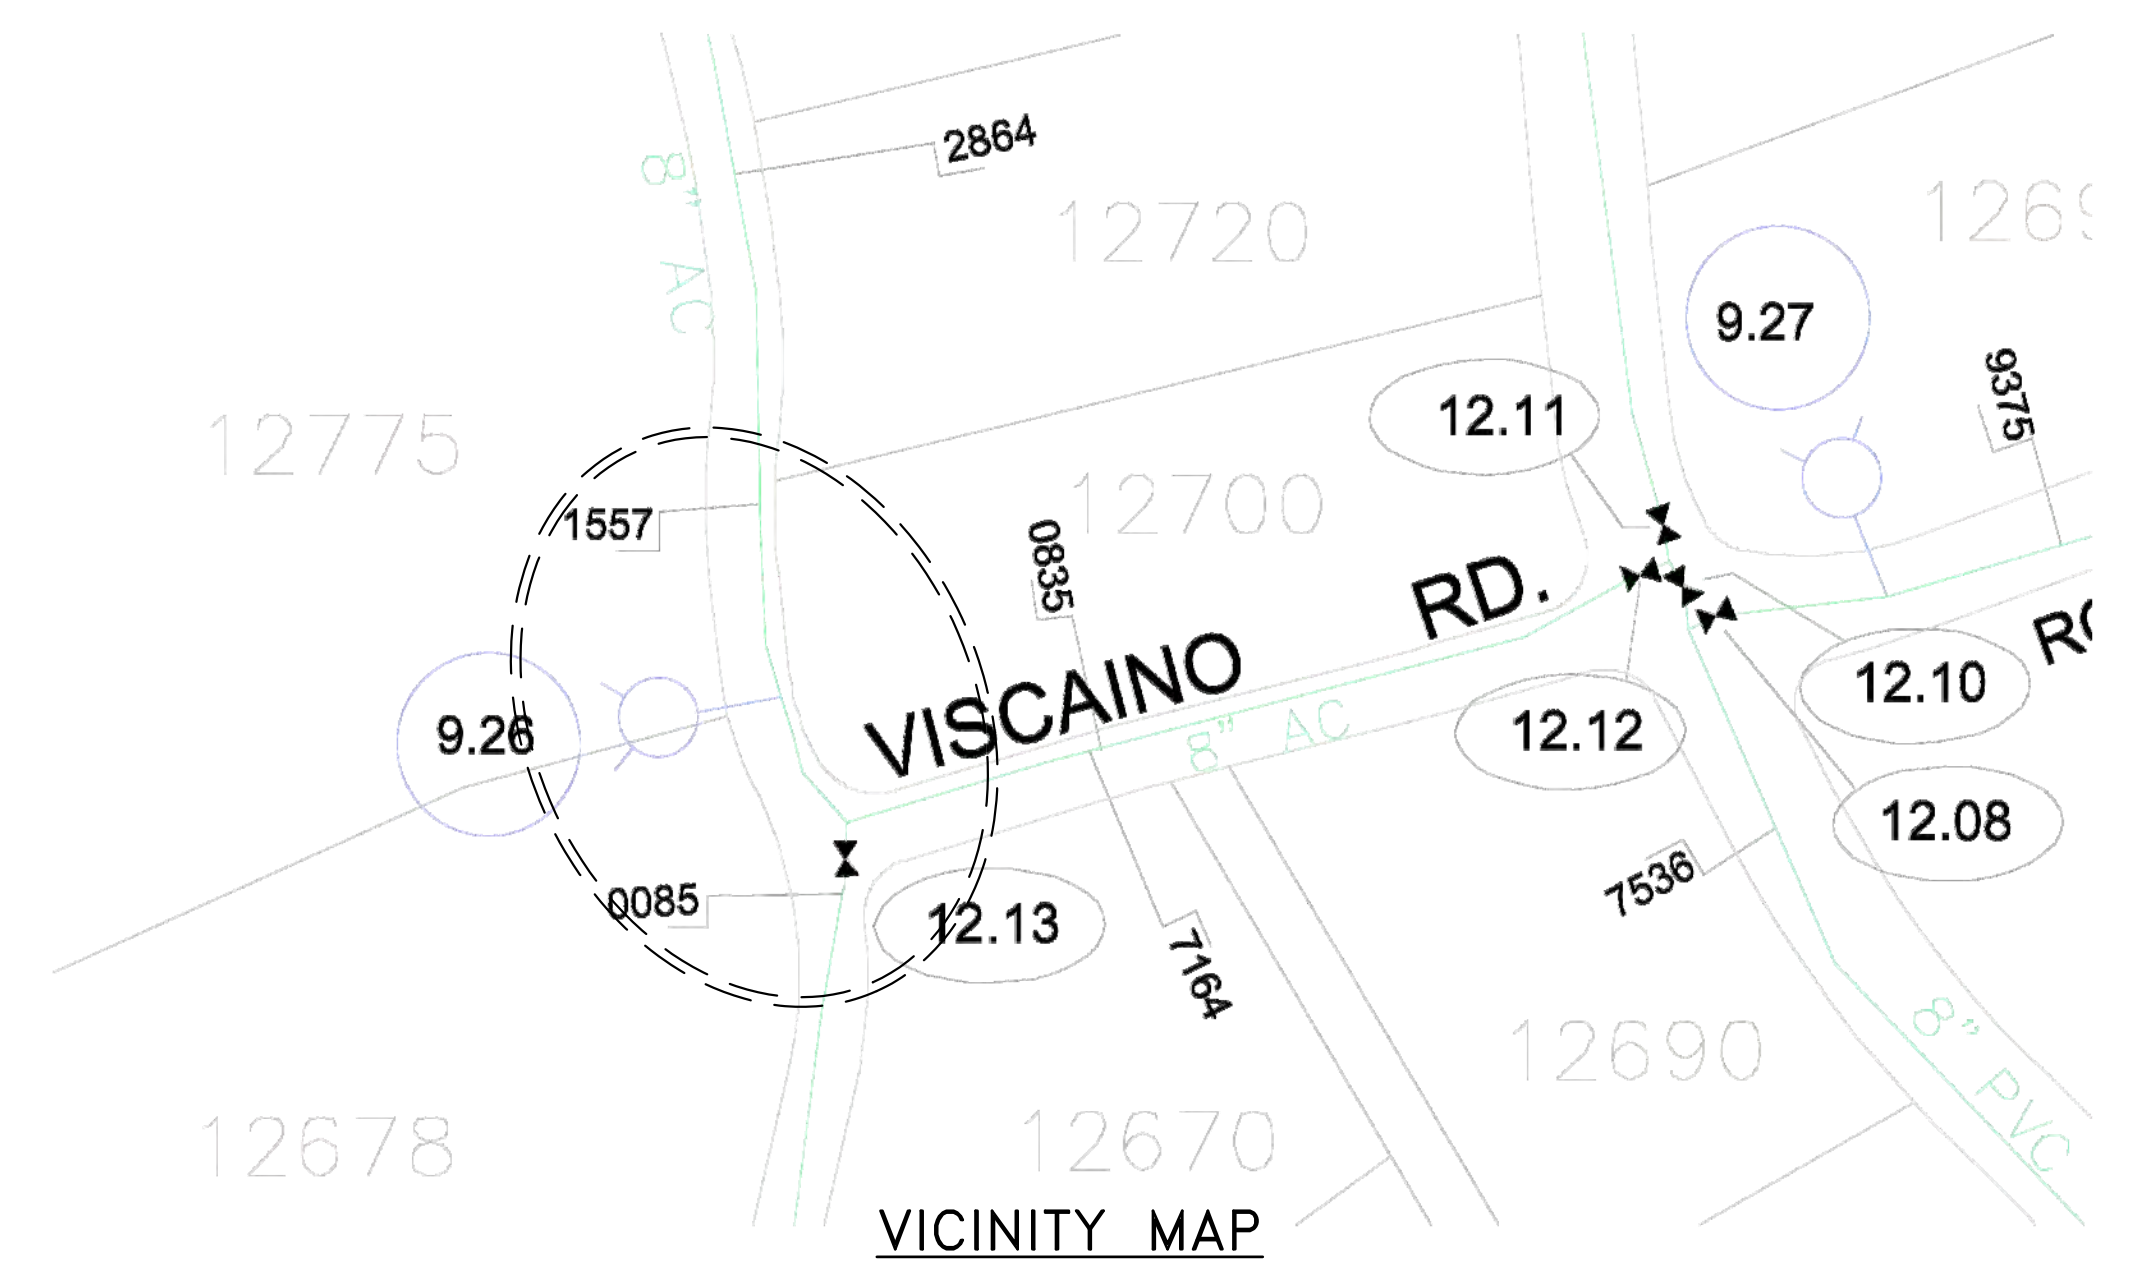
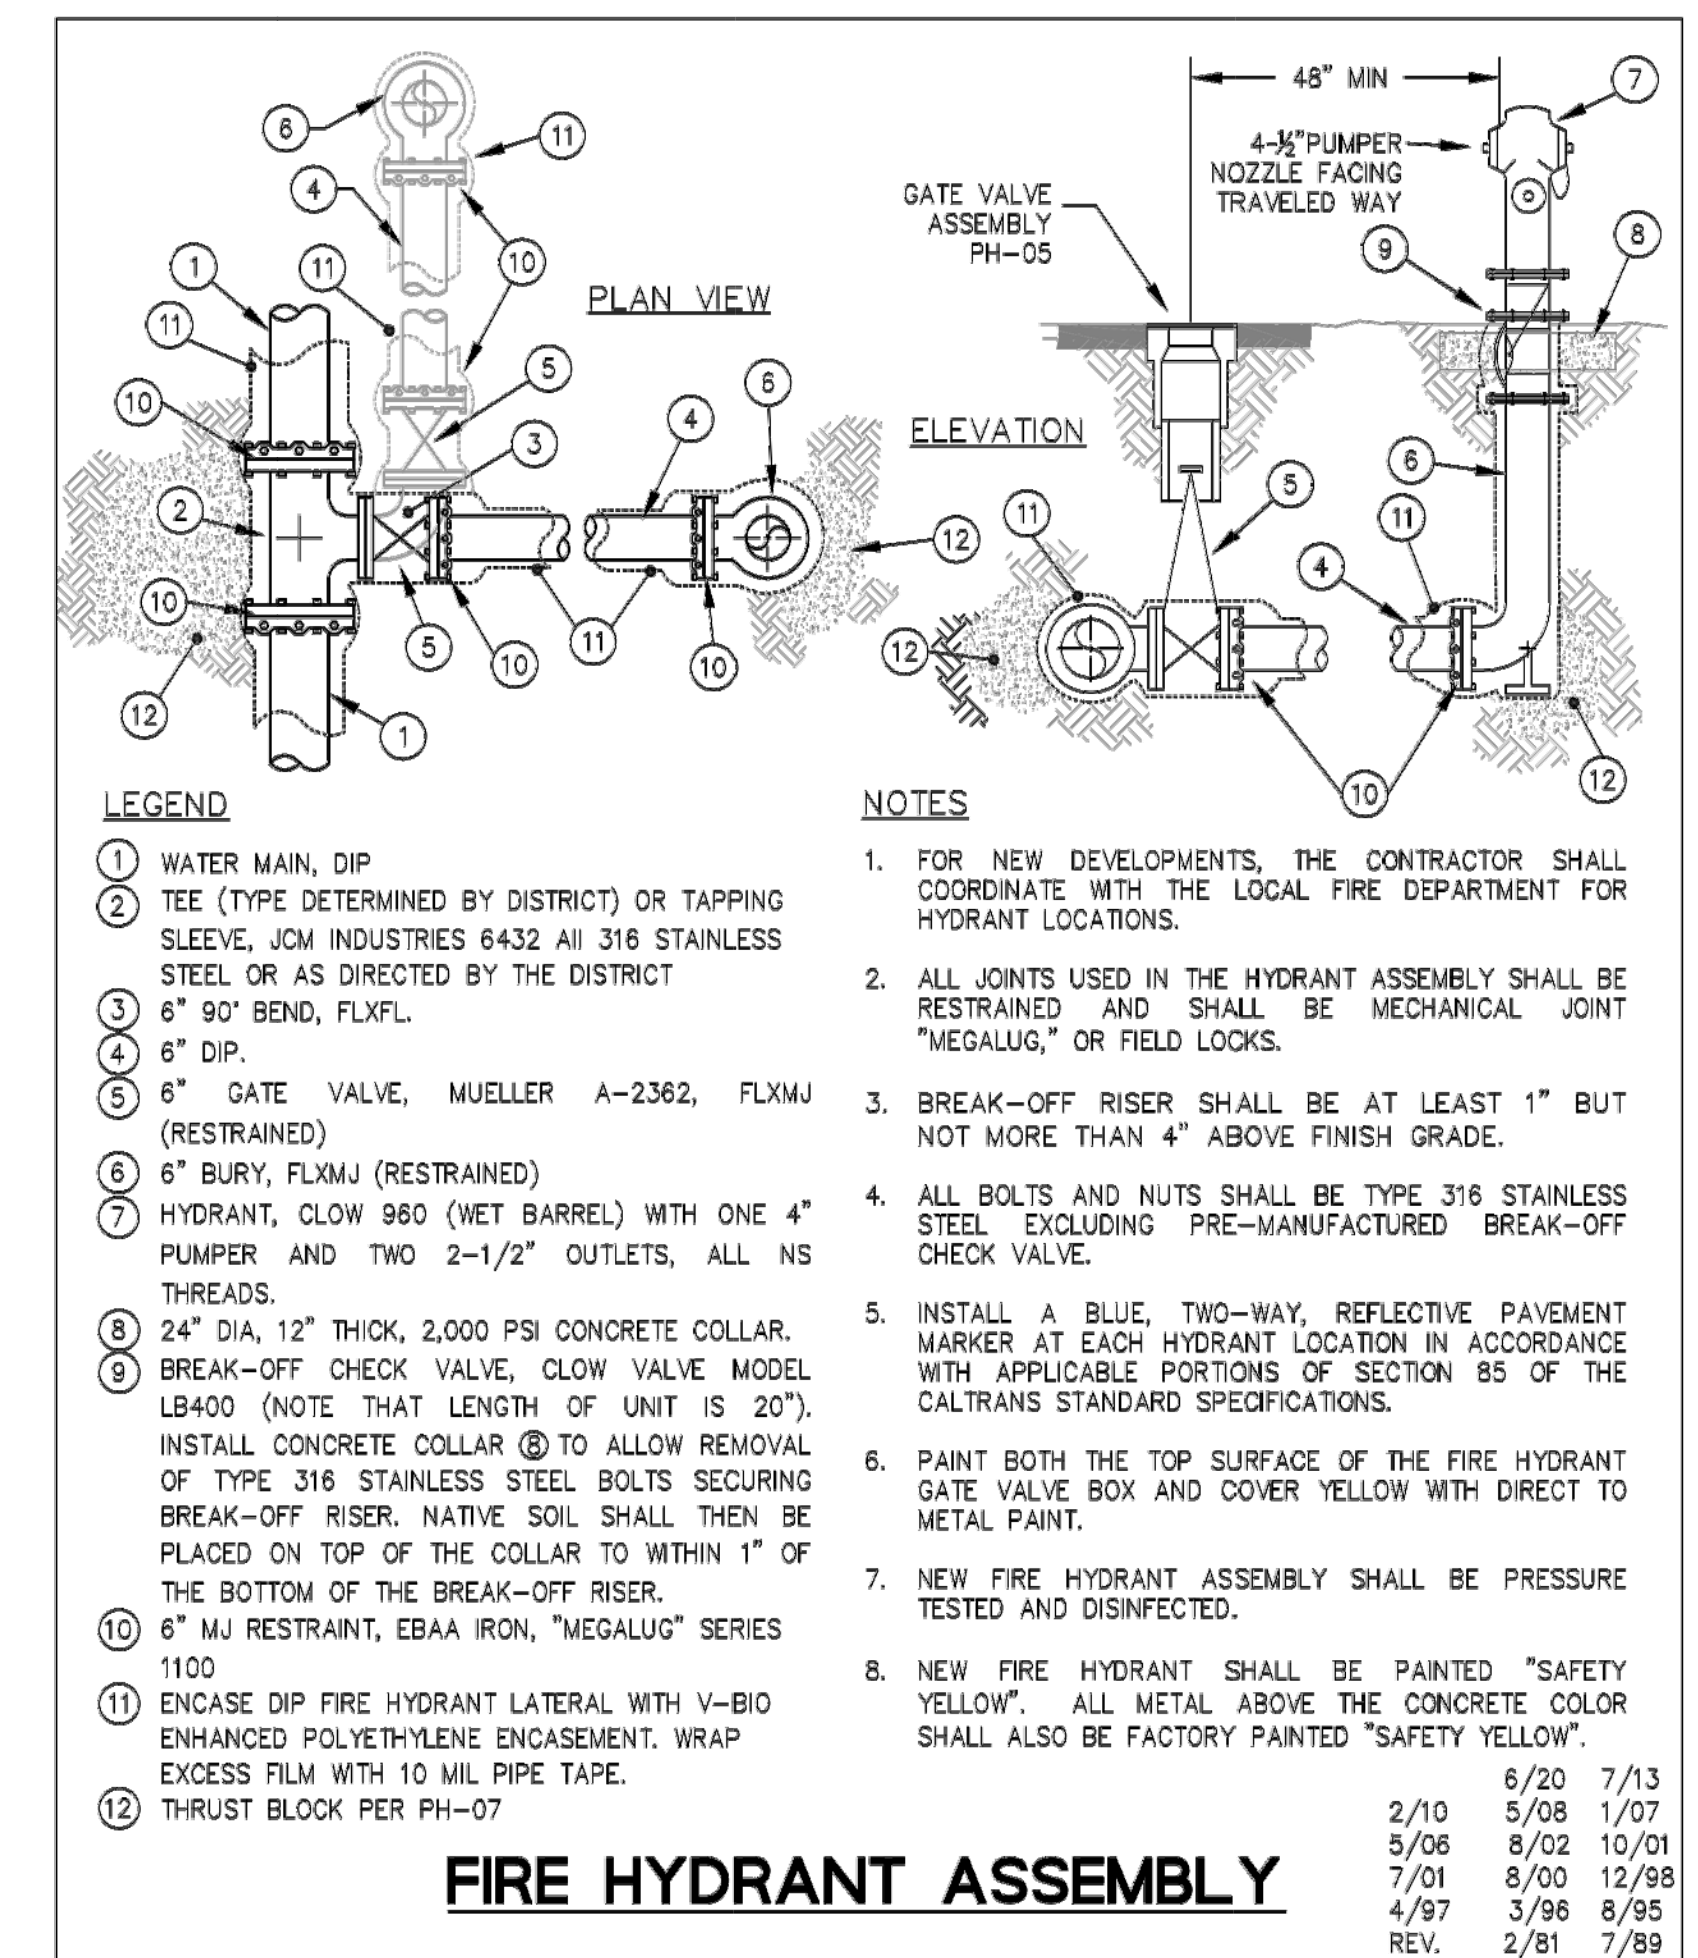
PLAN VIEW

Water can be seen coming out of the ground adjacent to the fire hydrant shutoff valve.
 Because of the location of the valve and leak, a repair will require a shutdown of approximately 20 homes.
 The hydrant does not appear to have a Check Valve.
 Hydrant is in good condition and can be reused

Leak needs to be repaired.
 With its current configuration if the hydrant was damaged it would be very difficult to shut off.
 We recommend replacing the hydrant lateral, installing a check valve , and installing a new gate valve that would allow the hydrant/lateral to be isolated from the water main.
